**Slope Stability Assessment and
Delineation of the Erosion Hazard Limit**

**Proposed Residential Subdivision
819 County Road 23
Merrickville-Wolford, Ontario**

PROJECT #: 210816

April 8, 2024

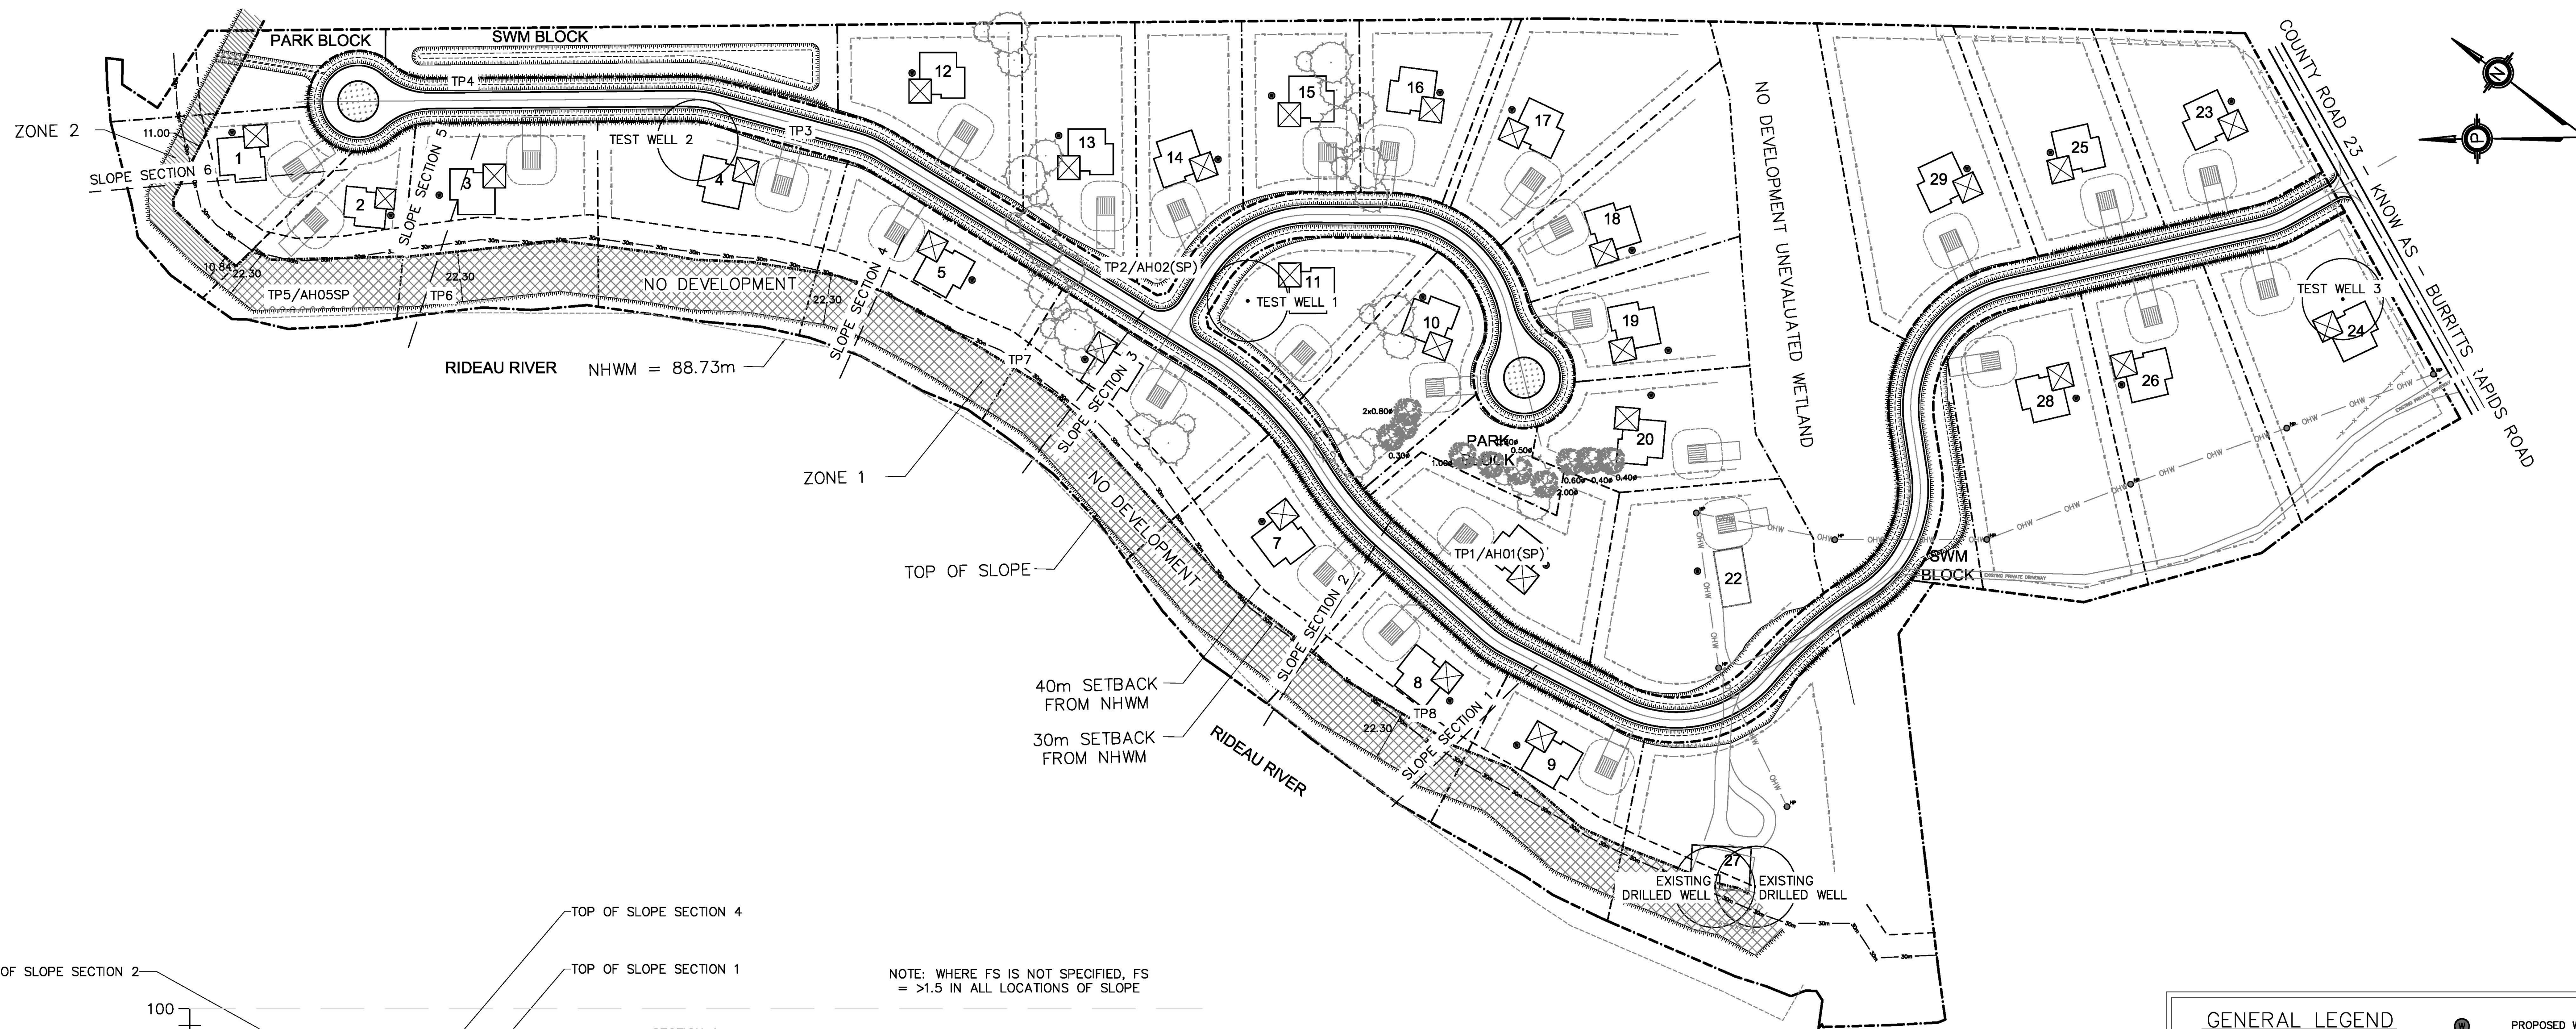
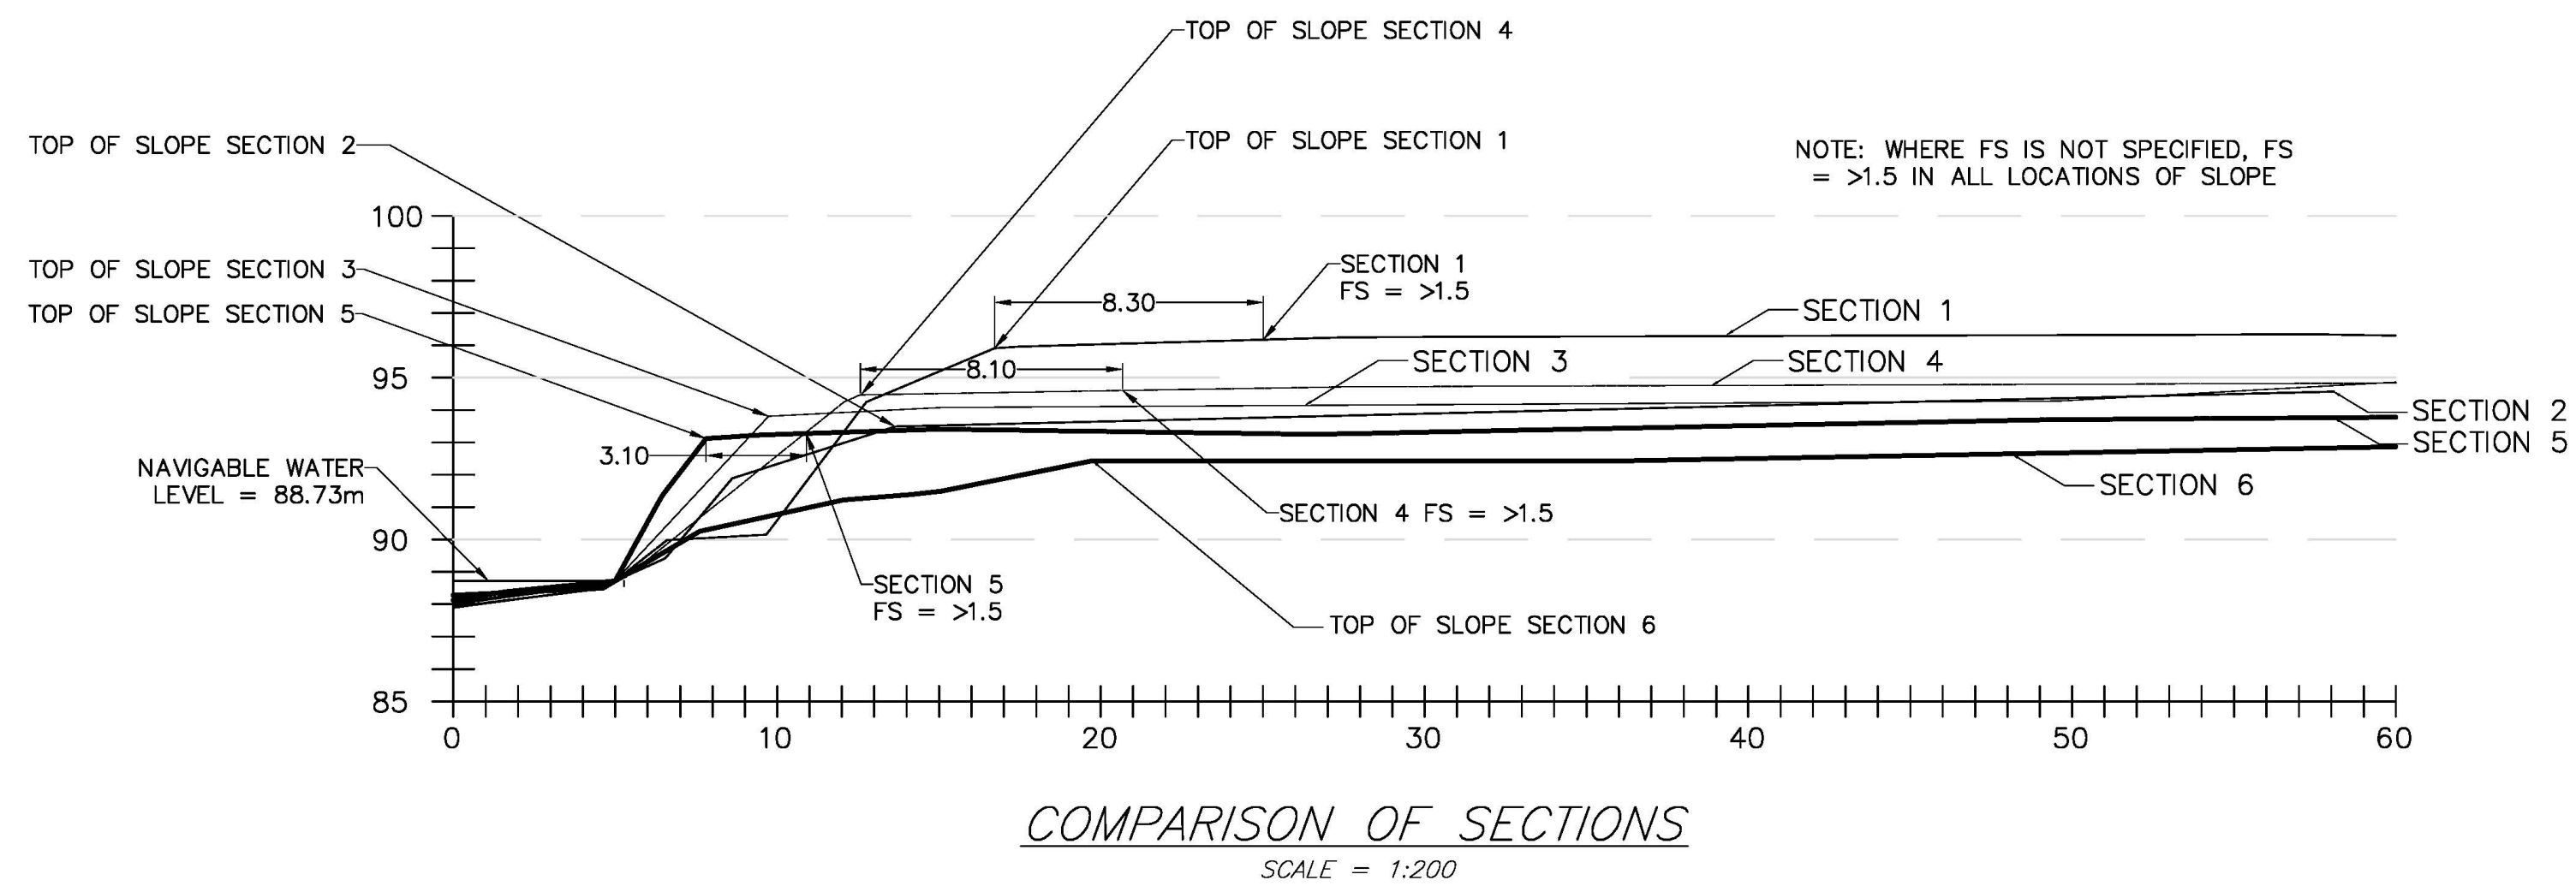
SLOPE SECTIONS AND LIMIT OF HAZARD LANDS SETBACK
SCALE = 1:1500

The Erosion Hazard Limit setbacks in Zone 1 and Zone 2 of 22.3 metres and 11 metres from the top of the slope respectively are illustrated on drawing 210816-SLP. This setback represents a limit for the proposed development at the site.

The top of slope at each lot line is indicated on the attached drawing 210816-SLP. The top of the slope should be verified between the lot lines during site specific grading of each individual lot as required by the geotechnical engineer and/or an Ontario Land Surveyor taking into account the change in slope inclination and topographic conditions.

Based on the results of this slope stability assessment and delineation of the Erosion Hazard Limit for the proposed development, it is considered that an Erosion Hazard Lands Setback in Zone 1 and Zone 2 of 22.6 metres and 11 metres respectively, is appropriate for the site. The Erosion Hazard Limit has been illustrated on drawing 210816-SLP
