**Environmental Impact Study (EIS)  
&  
Headwater Assessment**

**819 County Road 23, Merrickville, ON**  
Part Lot GORE, Concession GORE  
Township of Wolford  
United Counties of Leeds and Grenville

**July 2022**

**BCH Environmental Consulting Inc.  
20373 Bethune Street,  
South Lancaster, On  
K0C 2C0**

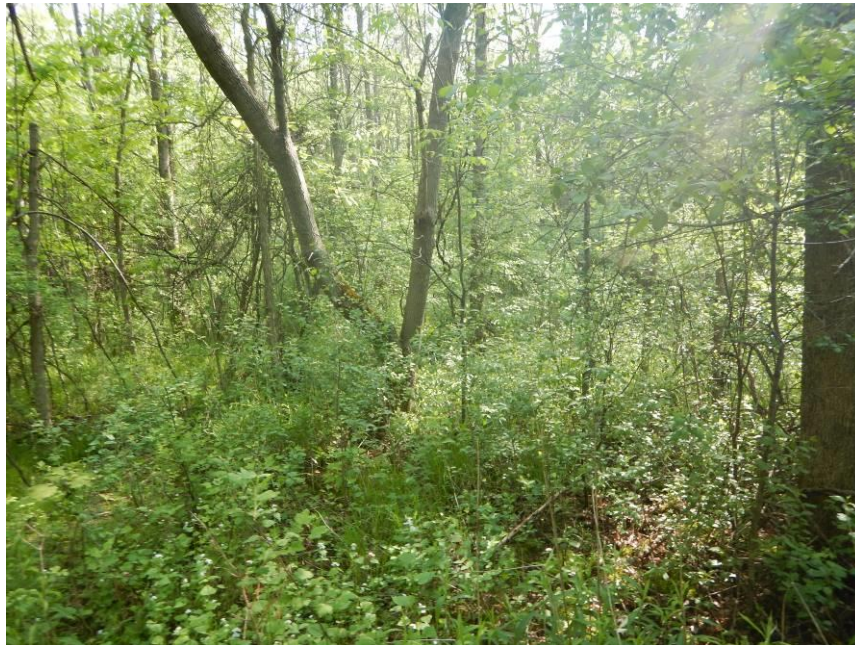
This community makes up a large portion of the subject lands. Tree composition and size was highly variable throughout. This location was highly disturbed by human activity (trails and evidence of past clearing activities). The average tree diameter was highly variable ranging from 10cm to 30cm. This was a deciduous forest with deciduous trees providing an average of 90% cover, and coniferous trees providing an average of 10% cover. The canopy and sub-canopy varied in dominance. The canopy (8-10m tall; 5-60% cover) was dominated by green ash followed by white ash. The sub-canopy (6m tall; 50-90% cover) was dominated by ash (green and white) followed by apple, common buckthorn and hawthorn. The understory (1-3m tall; 60-80% cover) was overdeveloped and consisted of prickly-ash, apple, common buckthorn, ash and nannyberry. The ground layer provided 60 % cover and included grasses, sedges, hickory regeneration, and asters. Within the eastern edge of this community along the property line there are large oaks and maples (50-90cm DBH). The occasional single and clump of coniferous tree are present throughout (white pine and white cedar). Some small areas within the northern portion of this community lack the canopy and sub-canopy layers, and are dominated by apple, common buckthorn, prickly-ash, ash and hawthorn.

Photo 1: Fresh Ash Deciduous Forest (May 21, 2022)

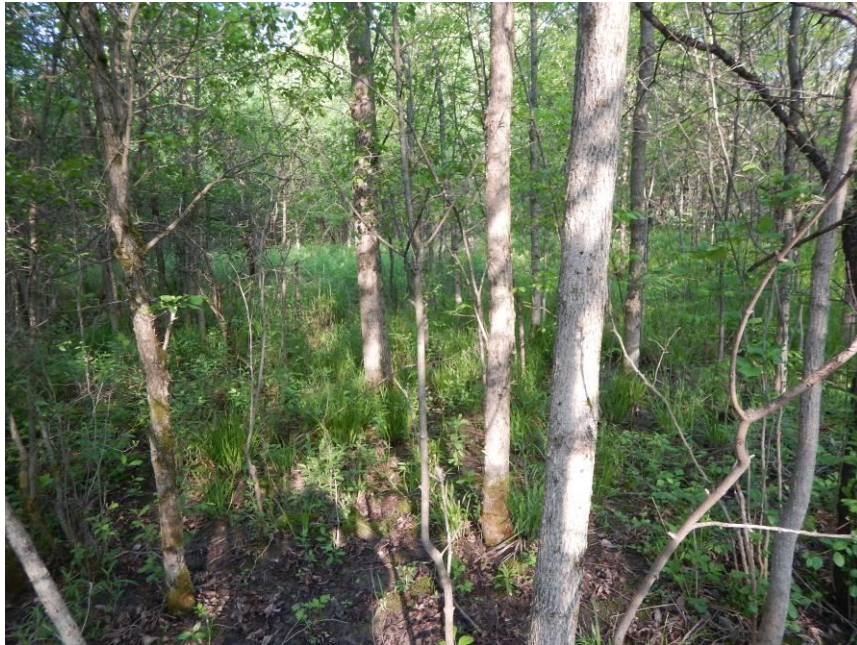
Photo 2: Fresh Ash Deciduous Forest (May 21, 2022)

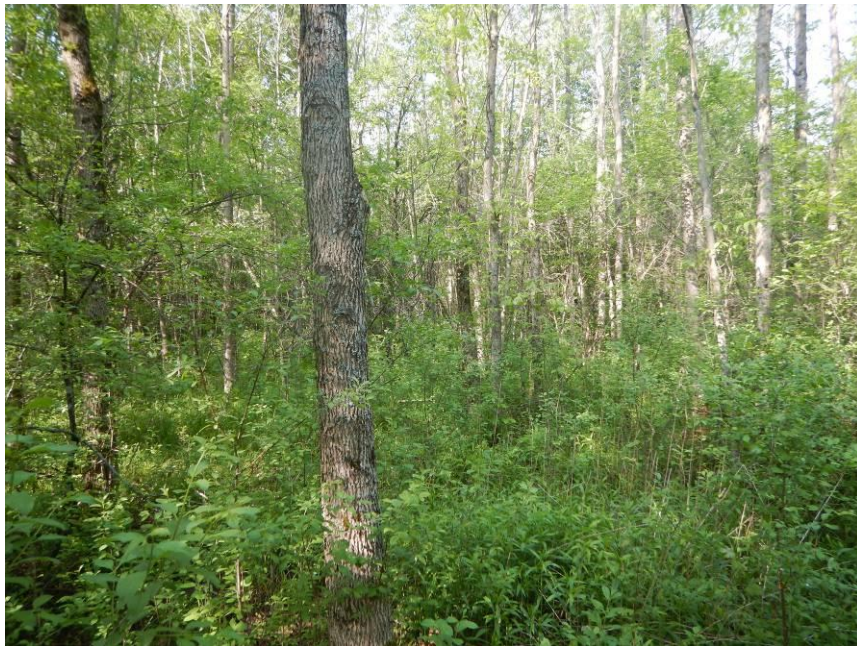
Photo 3: Fresh Ash Deciduous Forest (June 6, 2022)

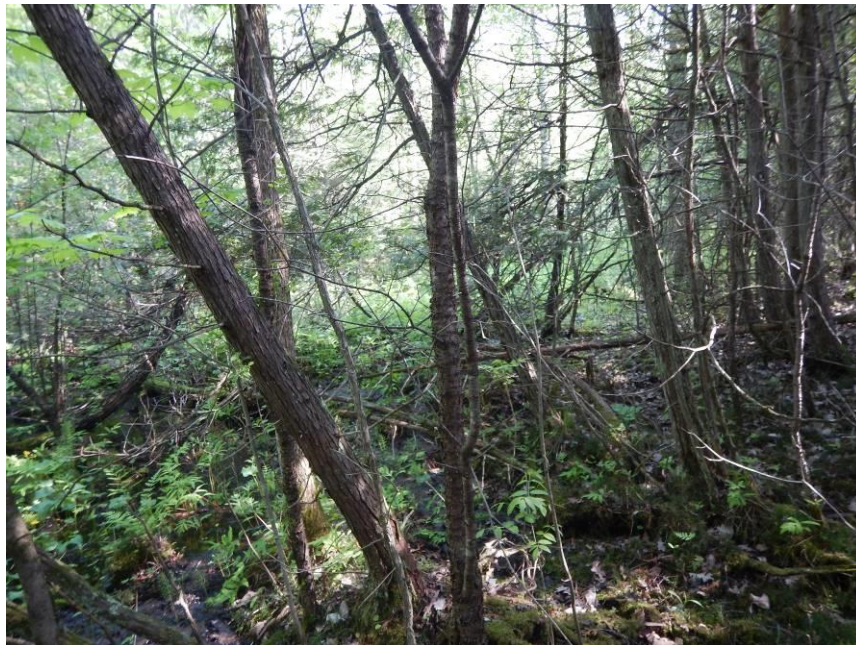
This community is present within the southern portion of the subject lands, and is an upland transitional area between the swamp and forest. The average tree diameter was 10cm to 20cm. This was a coniferous forest. The canopy was the dominant layer. The canopy (8m tall; 75-95% cover) was consisted of white cedar with the very occasional white birch, and green ash. There was no sub canopy or understory. The ground layer provided 20-40% cover and included grasses, sedges, sensitive fern.

Due to the presence of cedar, green ash and sensitive fern this community was suspect of being potentially a wetland, soil samples were taken to determine the moisture regime to aid with the decision making. The moisture regime within the forest was Moderately Moist (4). The Ontario Wetland Evaluation System (OMNR 2014) classifies wetlands as those areas with hydric soils, which have a Moisture Regime of 6 or higher, and nearly hydric soils, which have a Moisture Regime of 5. Under this classification this community did not contain hydric, or nearly hydric soil. The moisture regime of the forest community was Moderately Moist (4) which under the Ontario Wetland Evaluation System is not considered wetland.

Photo 4: Fresh-Moist White Cedar Coniferous Forest (May 21, 2022)

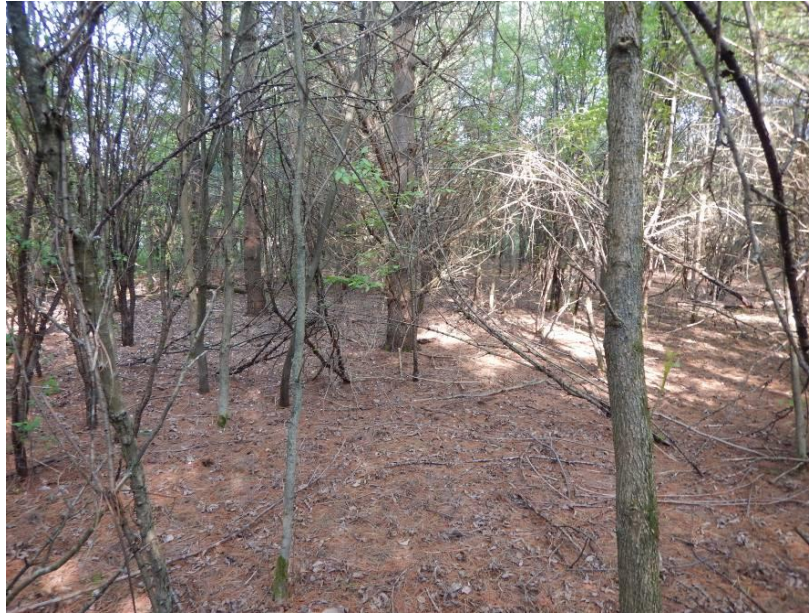
An unmaintained overgrown white pine plantation was present within the northern western portion of the subject lands. The average tree diameter was 30cm. Tree cover consisted of white pine. There was prickly-ash and green ash present in clumps within this community. The ground layer included grasses, sedges and asters.

Photo 5: White Pine Coniferous Plantation (May 21, 2022)

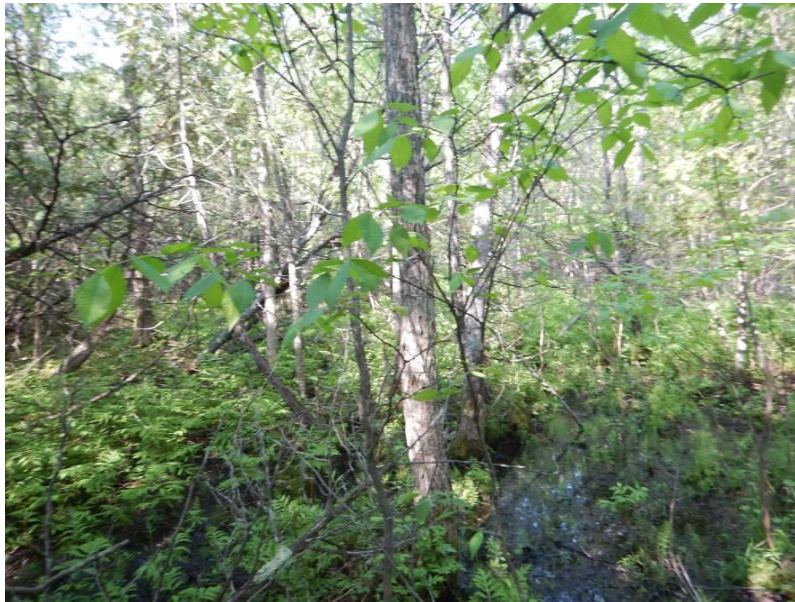
This swamp is present within the southern portion of the subject lands. The average tree diameter was 10-20cm. This wetland presented three forms: deciduous tree (black ash, green ash and American elm), coniferous tree (white cedar, and tamarack), and herbaceous plant (sensitive fern, marsh marigold, spotted jewel-weed, and horsetails). Water was present, no defined channel was present, fish habitat is possible within this swamp but highly unlikely (see section 3.7.1.2), and turtle habitat is fairly unlikely as water lacked suitable depth and tree cover limits basking opportunity.

Photo 6: Mixed Swamp (May 21, 2022)

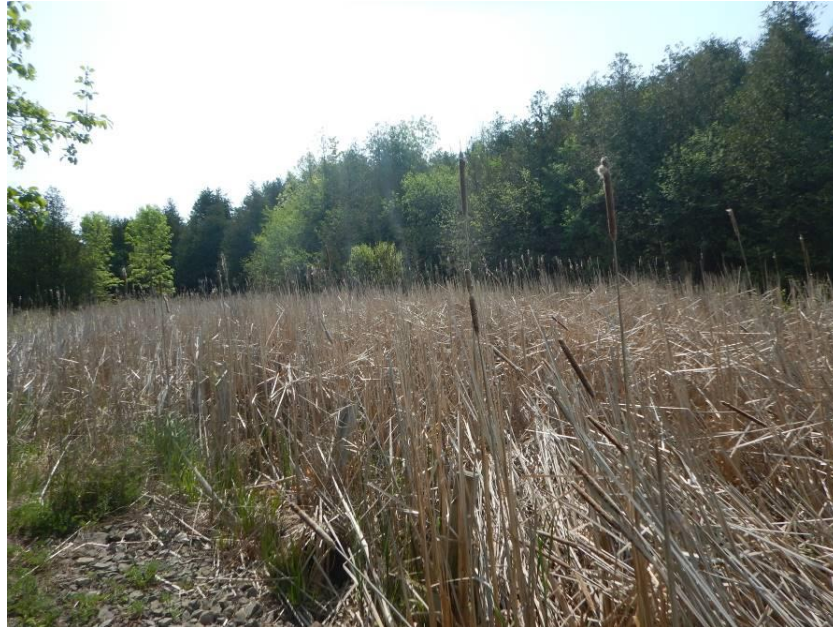
This marsh is present within the southern portion of the subject lands directly across the driveway from the mixed swamp and adjacent to the Rideau River. This wetland presented two forms: robust emergent (broad-leaved cattail) and herbaceous plant (sensitive fern, marsh marigold, spotted jewel-weed, and horsetails). Shrubs are present along the edges of this marsh (red-osier dogwood and willows). Water was present, fish habitat is possible within this marsh but highly unlikely, and turtle habitat is fairly unlikely as water lacked suitable depth and the area is choked with cattail.

Photo 7: Robust Emergent Marsh (May 21, 2022)

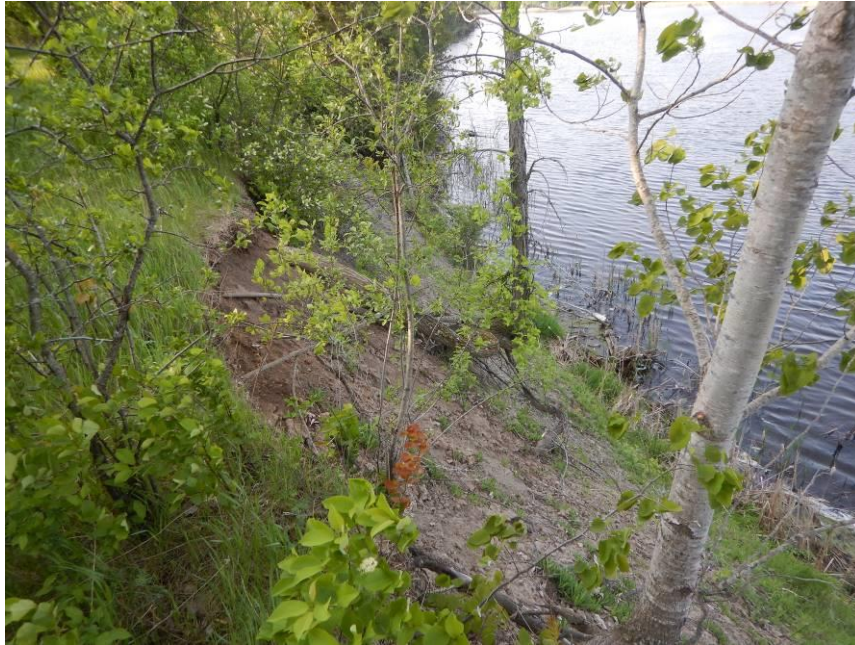
The Rideau River bordered the western and northern portions of the subject lands. The majority of the shoreline consisted of a steep (40-80°) 3-5m drop. The river banks exhibited signs of active erosion throughout (undercutting/failing). The banks were for the most part fully treed (white cedar, bur oak and white pine), with a thick understory (prickly-ash, common buckthorn, and apple) with some more bare areas (Photo 8). Rideau River supports a multitude of aquatic species such as fish and turtles.

Photo 8: Rideau River Shoreline (May 21, 2022)

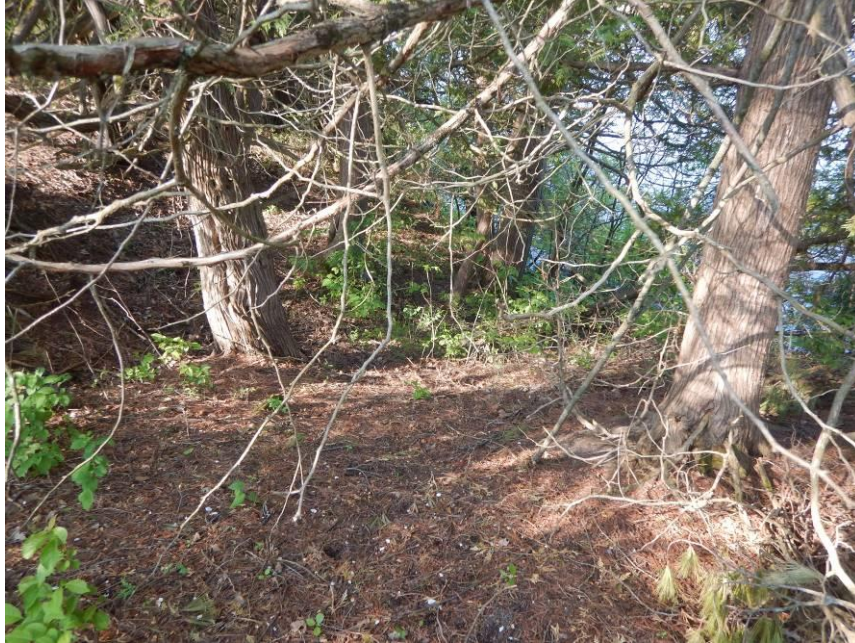
This unnamed watercourse is situated within the forested area of the subject lands. It flows in a west direction into the Rideau River. Tributary 1 was approximately 160 m in length. The channel was man-made and confined with a straight pattern. There is a drop at the mouth with no defined banks making upstream movement for fish very unlikely. Additionally, during all site visits the downstream portions of this tributary were dry which prevents fish movement in these areas. This can be attributed to two “crossings” that have trapped some water between them and poor grading. These crossings are just slightly built-up areas (soils or rock), so that vehicles can access. The first is located approximately 10m from the Rideau River. Upstream of the first crossing the average channel width was 1.7m and the average bankfull height 16cm. Substrate consisted of fines, no in-water cover was present.

During the May 21, 2022 visit, the average wetted width and water depth was 0.8m and 4cm (range: 1-10cm), respectively. It should be noted that the downstream end was dry but water was present upstream of the first crossing. The hydrological flow habitat consisted of standing water.

Photo 9: Tributary 1 Downstream end where it enters the Rideau River – Steep Drop, No Defined Banks (May 21, 2022)

Utilising the guideline and the data collected at each tributary the management recommendations are: No Management Required for Tributary 1, and Conservation for Tributary 2 (Table 6).

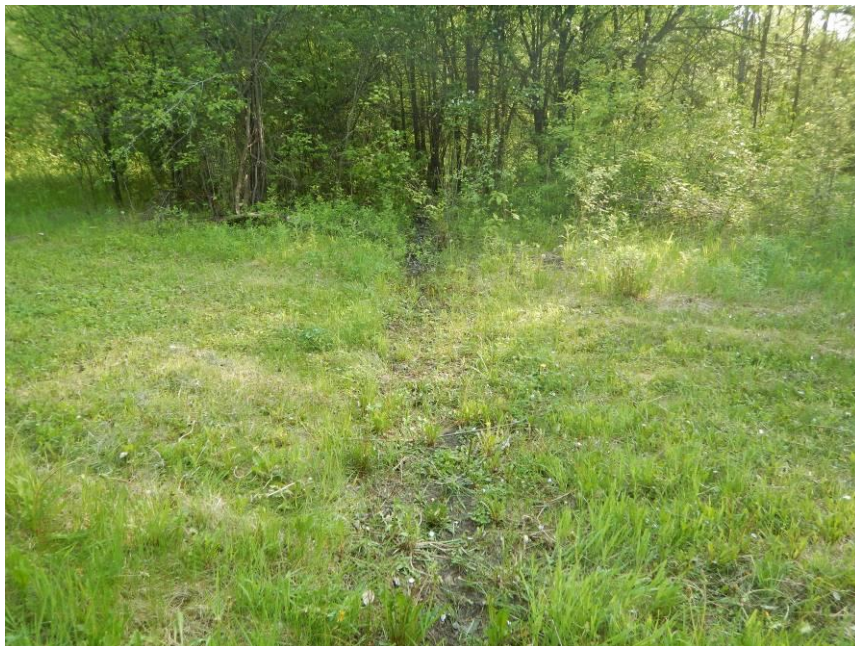
Photo 10: Tributary 1 Downstream end looking upstream at “crossing” - No Defined Banks (May 21, 2022)

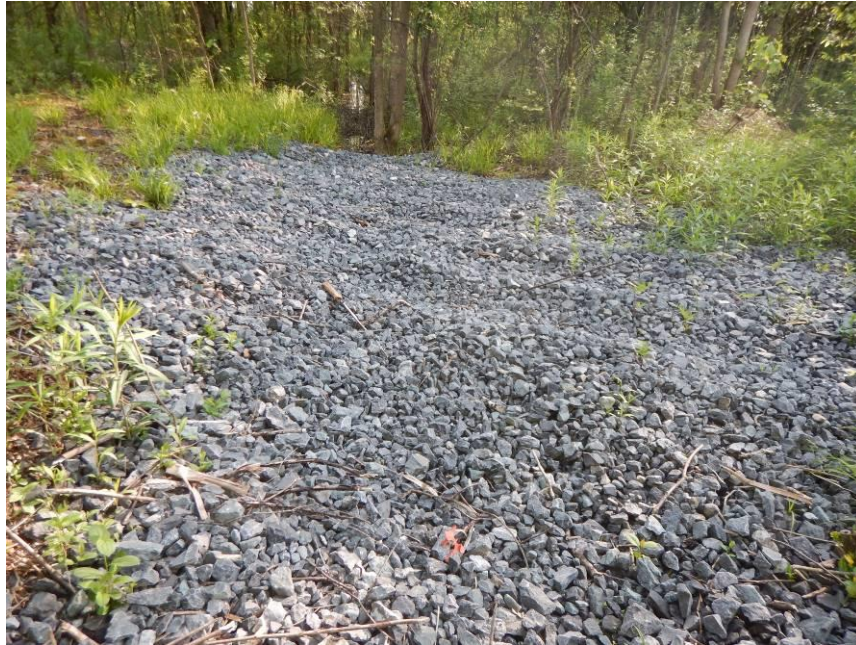
Photo 11: Tributary 1 looking upstream from mid tributary at the second “crossing” - No Defined Banks (May 21, 2022)

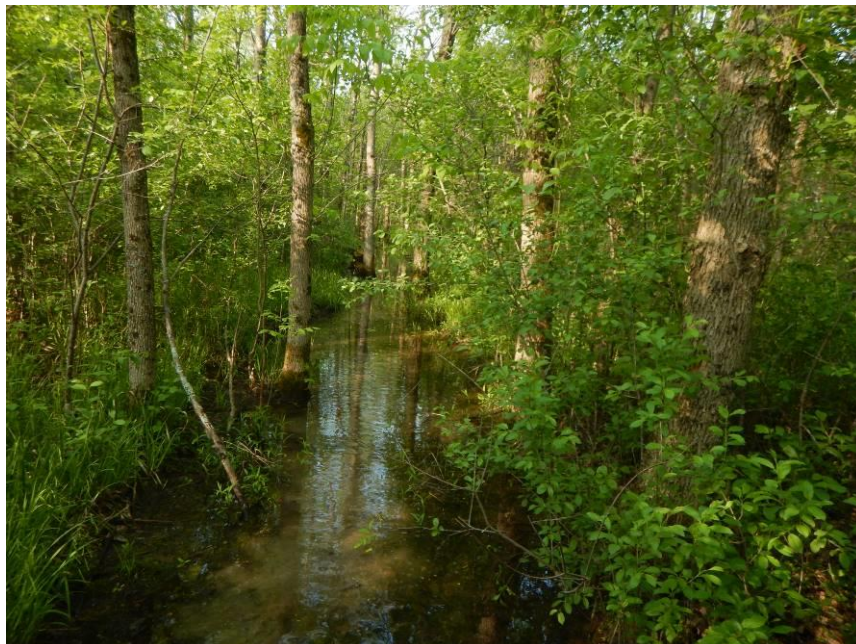
Photo 12: Tributary 1 water trapped due to the “crossings” and poor grading (May 21, 2022)

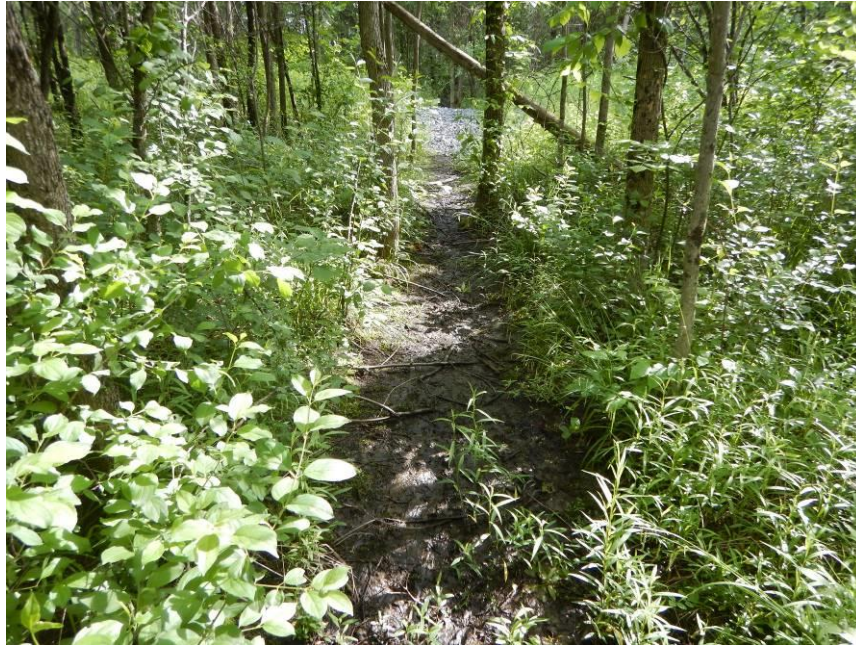
During the June 6, 2022 visit the entire tributary was dry.

Photo 12: Tributary 1 - Dry (June 6, 2022)

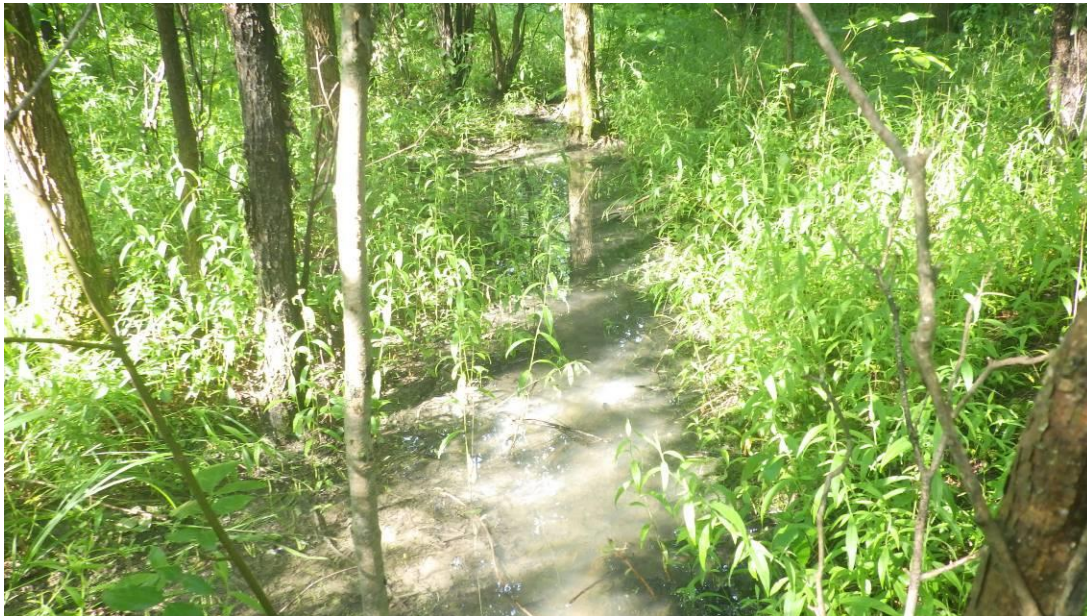
During the June 22, 2022 visit, the average wetted width and water depth was 0.8m and 3cm (range: 1-8cm), respectively. It should be noted that the downstream end was dry. The hydrological flow habitat consisted of standing water.

Photo 13: Tributary 1 water trapped due to the “crossings” and poor grading (June 22, 2022)

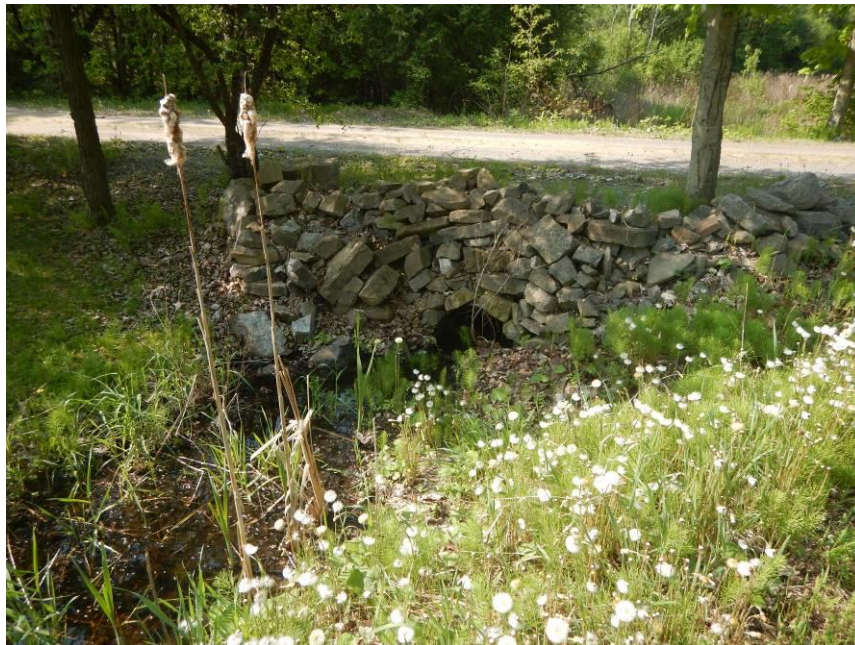
This unnamed watercourse is situated within the southern portion of the subject lands, and links the swamp to the marsh. It is apparent that the construction of this tributary was done to allow for the driveway crossing. Additionally, there is a second crossing at the upstream end. It flows in a west direction into the Rideau River. Tributary 2 was approximately 46 m in length. The channel was man-made and confined with a straight pattern. The average width was 2.1m and the average bankfull height 20cm. Substrate consisted of fines, in-water cover consisted of vegetation (cattails and reed canary grass). This very short tributary is not expected to represent fish habitat, access would be through the choked cattail marsh to get into the tributary then into the swamp with limited habitat. Most likely use for fish would be movement into the swamp but highly unlikely. Tributary 2 has very limited connection potential to the Rideau River, the choked cattail marsh is downstream.

Photo 14: Tributary 2 looking at the downstream end with the driveway crossing (May 21, 2022)

- Maintain, relocate, and/or enhance drainage feature and its riparian zone corridor;
- If catchment drainage has been previously removed or will be removed due to diversion of stormwater flows, restore lost functions through enhanced lot level controls (i.e. restore original catchment using clean roof drainage), as feasible;
- Maintain or replace on-site flows using mitigation measures and/or wetland creation, if necessary;
- Maintain or replace external flows,
- Use natural channel design techniques to maintain or enhance overall productivity of the reach;
- Drainage feature must connect to downstream.

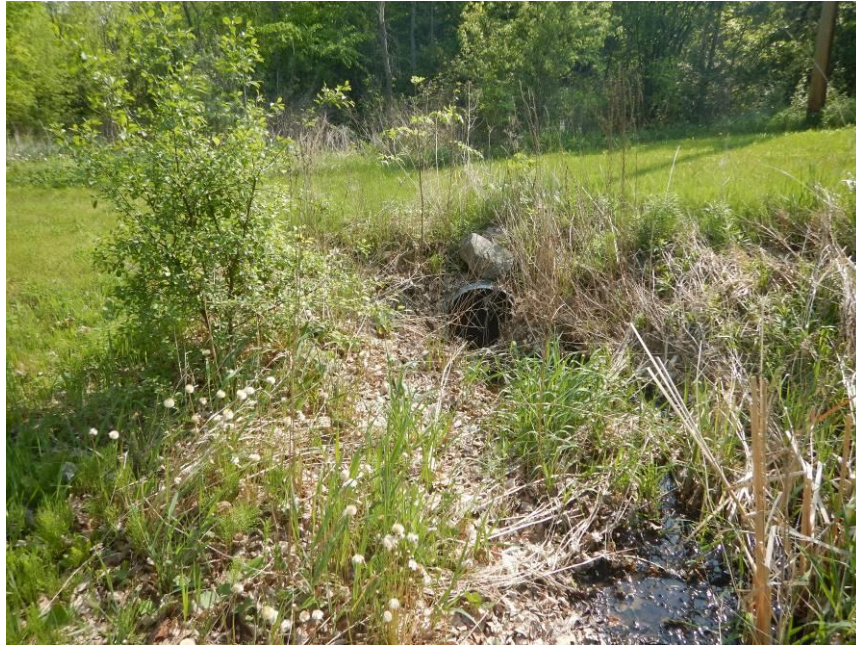
Photo 15: Tributary 2 looking at the upstream end with the crossing (May 21, 2022)

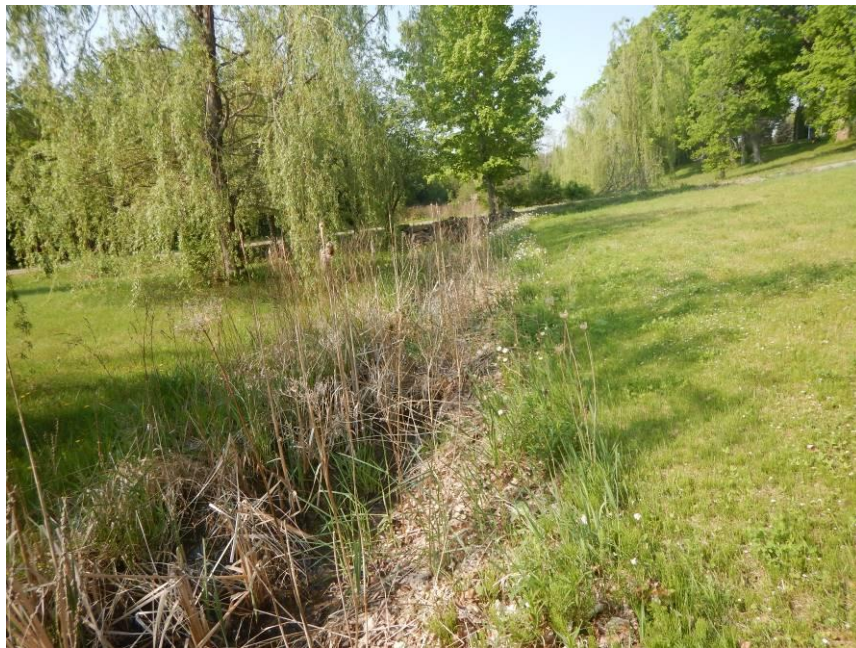
During the May 21, 2022 visit, the average wetted width and water depth was 1.2m and 17cm (range: 10-25cm), respectively. The hydrological flow habitat consisted of substantial flow.

Photo 16: Tributary 2 (May 21, 2022)

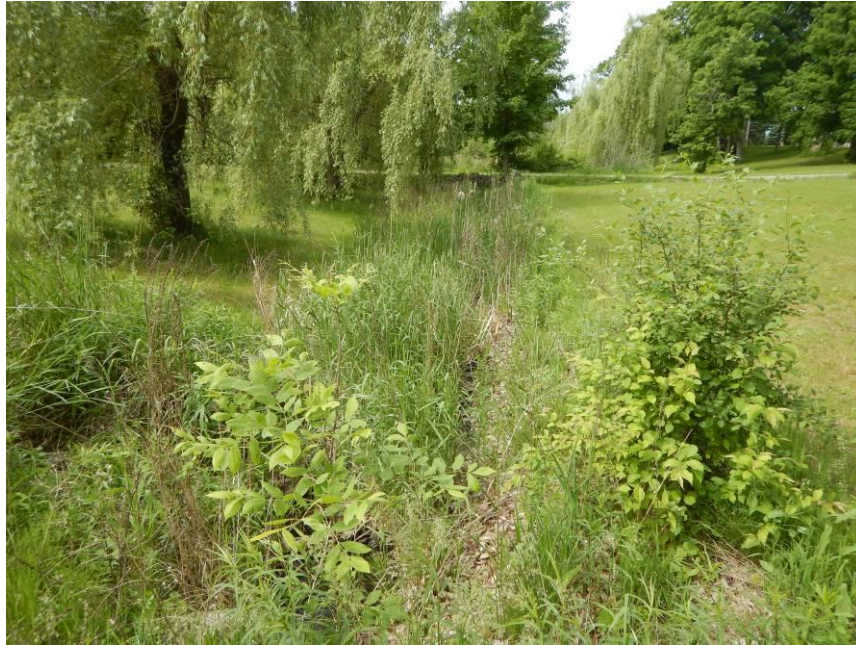
During the June 6, 2022 visit, the average wetted width and water depth was 1.2m and 19cm (range: 1-35cm), respectively. The hydrological flow habitat consisted of substantial flow.

Photo 17: Tributary 2 (June 6, 2022)

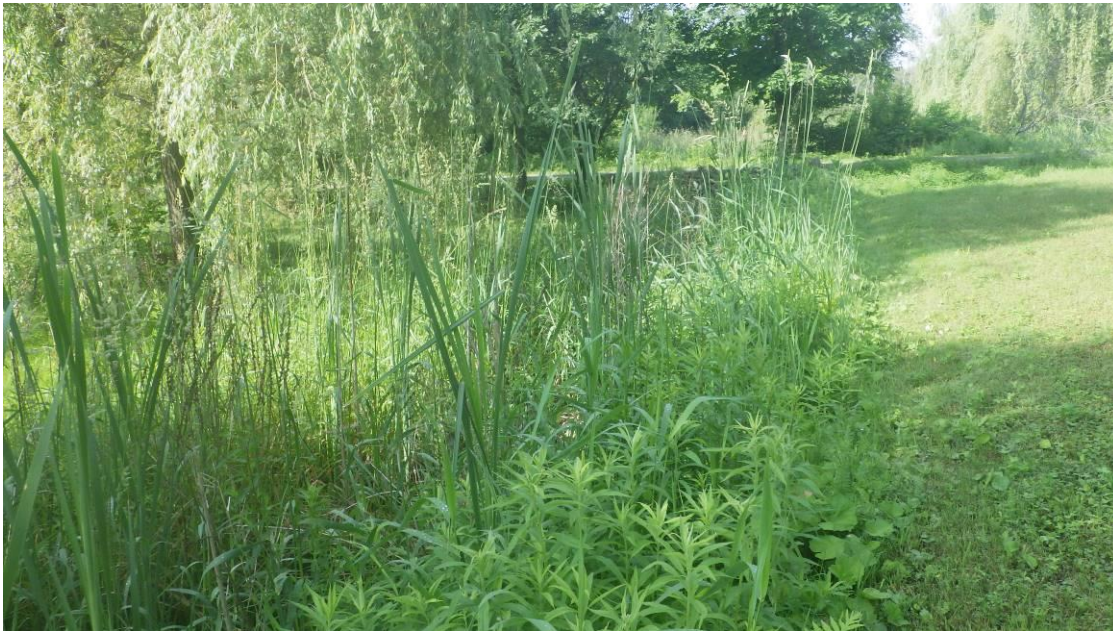
During the June 22, 2022 visit, the average wetted width and water depth was 1.4m and 10cm (range: 4-21cm), respectively. The hydrological flow habitat consisted of substantial flow.

Photo 18: Tributary 2 (June 22, 2022)

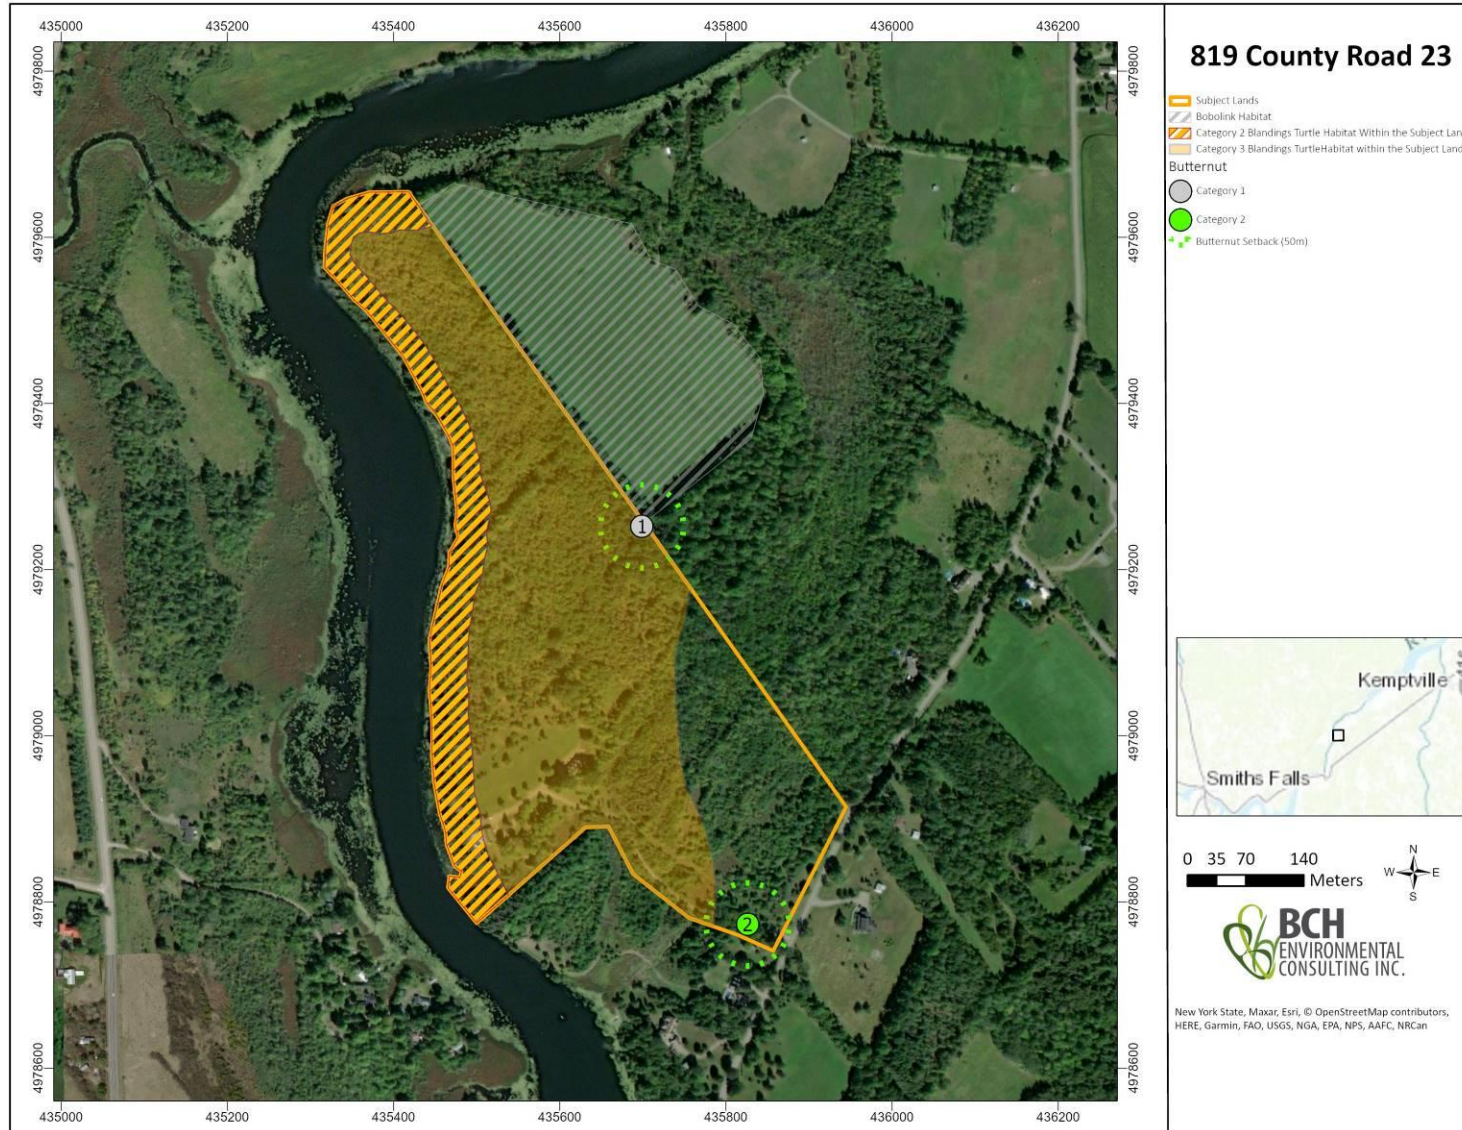
FIGURE 2: SPECIES AT RISK

- **Category 2:** the wetland complex that extends up to 2 km from an occurrence, and the area within 30 m around those suitable wetlands or waterbodies. As noted, Blanding's turtle was documented within 10 km of the subject lands. For the purpose of this report, the Rideau River will be considered to be Category 2 habitat. All proposed operations will be moved outside of the Category 2 habitat (Figure 2).

- **Category 3:** the area between 30m and 250m around suitable wetlands or waterbodies identified in Category 2, within 2 km of an occurrence. As demonstrated in figure 2, the subject lands are within 250m of the Category 2 habitat, therefore portions of these lands will be considered Category 3 habitat. Category 3 habitat provides essential movement corridors of up to 500m

Additionally a breeding bird survey was conducted within this property (3 visits; table 1), a pair of nesting bobolinks were observed within the above mentioned hay field (Figure 2). Additional birds observed nesting or displaying nesting behaviours include: common grackle, American robin, ovenbird, blue jay, black-capped chickadee, phoebe, red-eyed vireo, chipping sparrow, veery and common yellowthroat.
